**Y-12
NATIONAL
SECURITY
COMPLEX**

Effect of CTE on Fatigue Cracking of Stainless Steel Vessels

**E. L. Bird
T. M. Mustaleski
Technology Development**

Date of Issue: January 2002

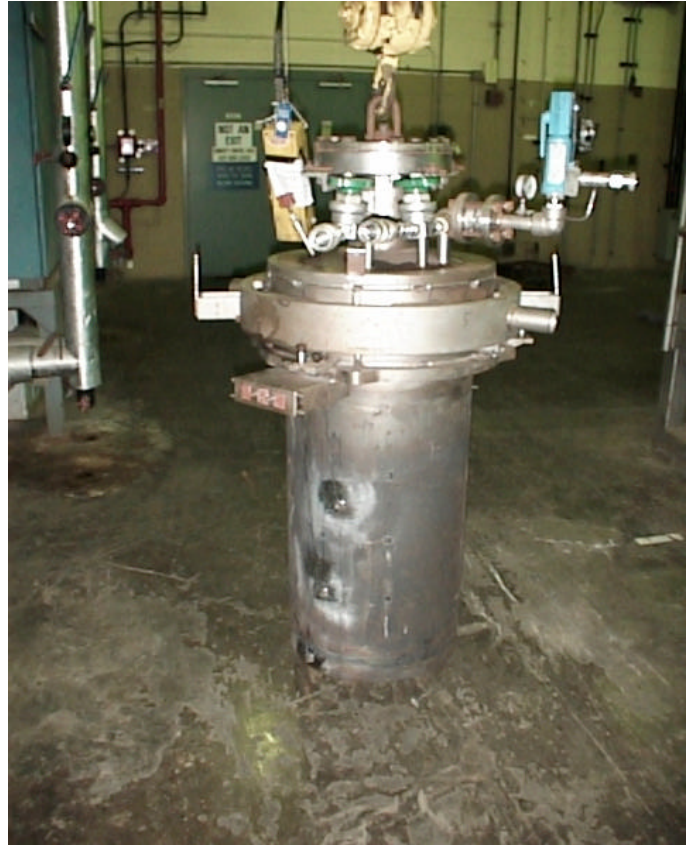
Hydride reactor vessels are used to produce lithium hydride in an exothermic reaction process. During a recent visual inspection of some of these vessels, circumferential cracks were discovered along the bottom portion of the vessel. One of the cracked vessels is shown in Fig. 1. Construction of the particular vessels in question occurred in the early 90's. A review of the process history revealed that after the factory acceptance test, a crack was found in the welded region of one of the Type 309S stainless steel vessels. The cracked vessel was repaired by machining away the original stainless steel weld metal, re-welding with INCONEL 617® filler wire from the outside, and buttering on the inside with ER-Type 309LT stainless steel wire. Subsequent thermal cycling and radiography of the repaired vessel displayed no cracks so the other vessels were repaired in the same manner.

Figure 1. Hydride reactor vessel

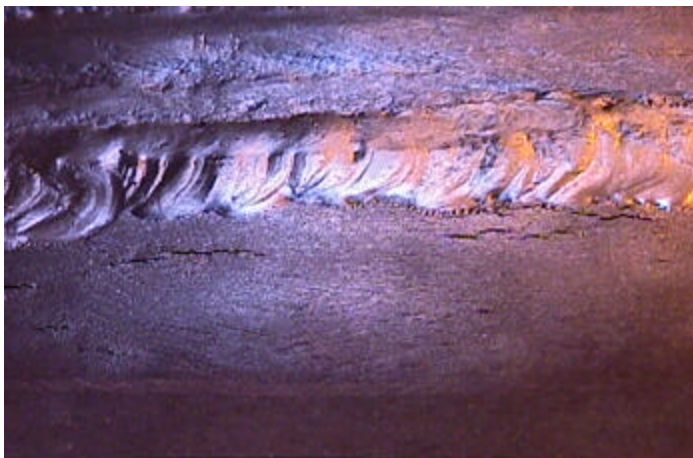
A history summary of the operating life of these vessels and inspection results are provided in Table 1. A typical operating cycle consists of ramping up slowly to about 700°C (1300°F), holding for several hours, and cooling by forced air. Most of the cracks were located along the circumferential welds at the bottom of the vessels. A few sections containing cracks next to the circumferential welds, similar to those shown in Fig. 2, were cut out of two of the vessel walls for failure analysis.

Fig. 2. Cracks adjacent to weld at bottom of vessel.

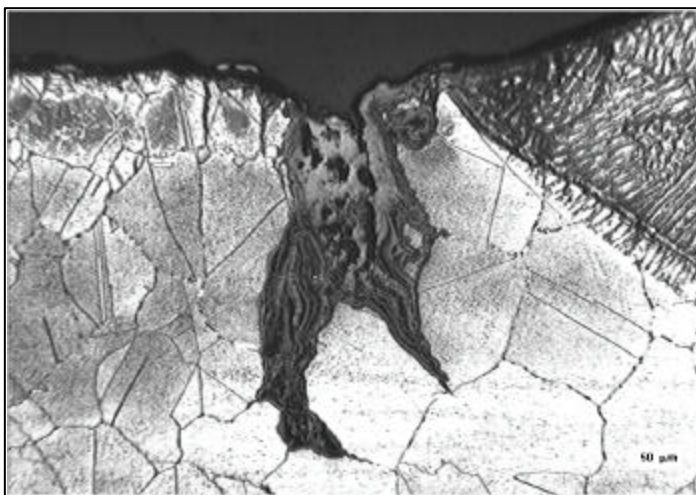
Fig. 3. Cracked region of Vessel No. 6.

water mixture. The microstructure was also examined using the scanning electron microscope (SEM) and backscattered electron imaging. Energy dispersive x-ray (EDX) was used to identify the metallic elements whereas the lighter elements were identified using the electron microprobe. The crack in Vessel #6 is shown in Fig. 3. The crack depth shown in Fig. 3 is approximately 300 μm and the microstructure appears similar to Type 309 stainless steel. The microstructure appears to be slightly sensitized with some evidence of large precipitates in the grain boundaries as shown in Fig. 4. Several specimens from Vessel #7 were prepared in the same manner for metallographic examination.

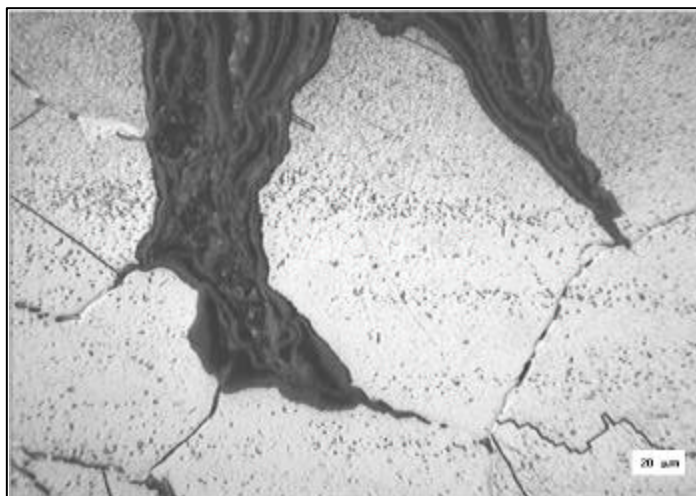
Fig. 4. Intergranular growth and presence of rod-shaped precipitates along grain boundaries.

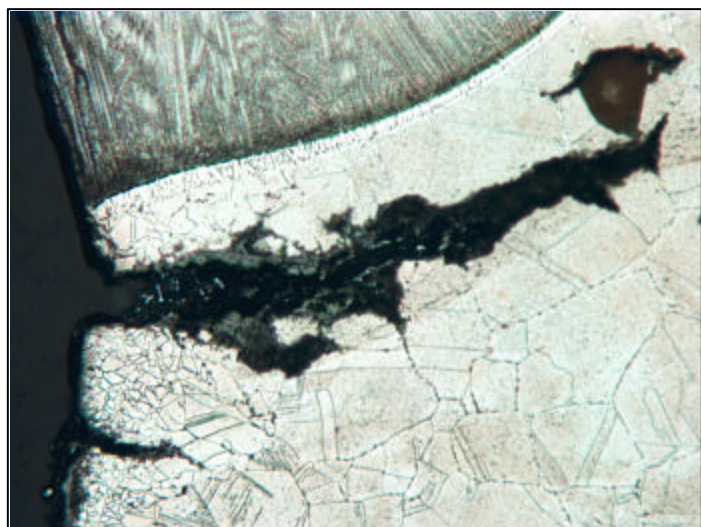
One of the cracked regions is shown in Fig. 5. The largest of these cracks is approximately 500 μm and some evidence of sensitization is noted by the string of grain boundary precipitates is shown in Fig. 6. A crack approximately 0.3 cm long was discovered in the base plate. Sections were also taken from the weld and base material to verify the filler metal and base metal. Chemical analysis revealed a partially diluted material that indicates that the filler metal is a nickel-based alloy similar to INCONEL 617® and a substrate material that is similar to Type 309 stainless steel as shown in Table 2.

Fig. 5. Cracked region of Vessel No. 7.

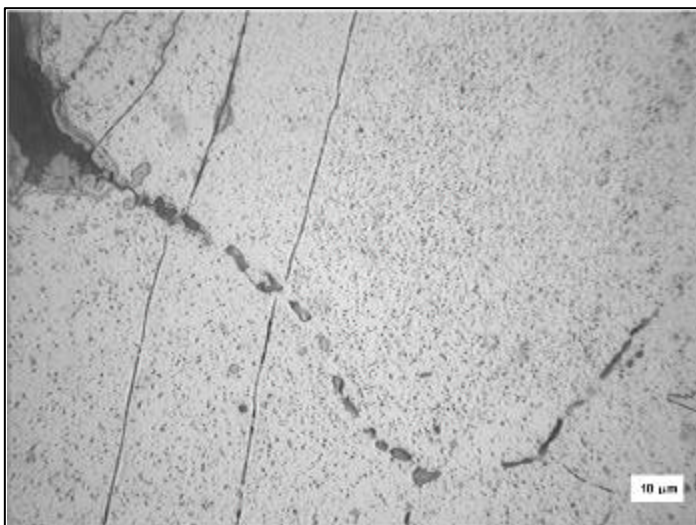
Fig. 6. Tip of crack from Fig. 5 showing formation of large precipitates along grain boundary.

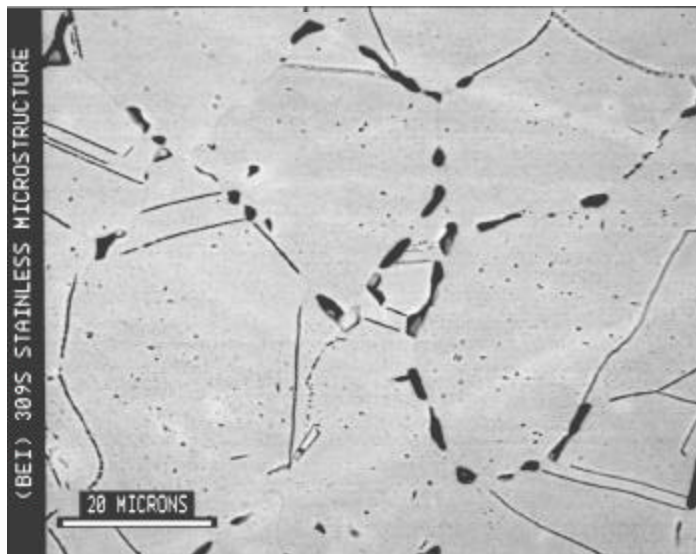
Grain boundary precipitates, which are seen in the microstructure shown in Fig. 7, near the crack, were determined by EDX to be Cr-rich. Carbon was also detected in the grain boundary precipitates using the electron microprobe.

Fig. 7. Section near crack showing precipitates rich in chromium and carbon in Type 309S.

The base material appears to be slightly sensitized with the presence of chromium-rich carbides, and cracking appears to follow some of these grain boundaries where rod-shaped carbides are aligned. Oxide is present along the surface and within the crack opening, especially in the larger, wider cracks. Traditionally, in those cases where sensitization is the primary cause of failure, there are typically Cr-depleted zones along the grain boundaries, cracking is branch-like, and a corrosive element is present. That is not the case here, at least, not in the

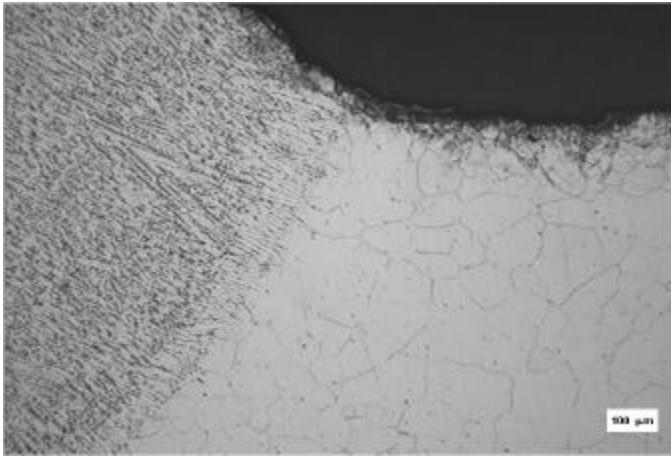
During the investigation of these cracked vessels, it was reported that vessels of a different design had performed satisfactorily in the past for this same application. Those vessels had curved bottoms and the filler weld metal was believed to be Type 309 stainless steel. According to some of the old records, the material was solution annealed and quenched, which is a standard practice used throughout industry to minimize sensitization in stainless steels. A section of one of the older curved-bottom vessels was analyzed to determine if the filler and base metal was indeed Type 309 stainless steel. However, the carbon results were found to be higher than the 0.08 wt % maximum specified for Type 309 stainless steel. Yet, the vessel apparently showed no evidence of cracking. Since it appears that cracking observed in the current vessels may be associated with some type of creep fatigue mechanism, the role of carbon in the alloy for prolonged periods of time at elevated temperatures becomes an important factor. Reduced carbon in solution in the low-carbon (Type 304L and 316L stainless steel) and stabilized grades (Type 321 and 347 stainless steel) results in reduced creep strength and creep-rupture strength [Ref. 1]. As the hold time at elevated temperature is increased, the effect of rupture ductility becomes more pronounced. The lower the rupture ductility, the lower the creep fatigue endurance for low carbon stainless steels. The higher the carbon content, the higher the creep fatigue strength, but with the higher carbon, the greater the chance of sensitization becomes a problem at these operating conditions. In addition, ASME B&VP code footnotes require the carbon content for Type 309 stainless steel to be 0.04 wt % minimum and 0.08 wt % maximum for use at these temperatures. Consequently, a decision was made not to use the vessel with the higher carbon content. A section of another curved-bottom vessel was examined for cracks, microstructure, and chemical analysis was performed to verify the filler metal. There were no cracks in this section. The microstructure, which is shown in Fig. 8, looked normal, and both the filler metal and base metal were identified as Type 309 stainless steel. In fact, the microstructure showed very little evidence of sensitization, which was rather surprising, because most material handbooks indicate that austenitic stainless steels, such as Type 309 stainless steel, become susceptible to intergranular corrosion when subjected to temperatures in the range of 480°C to 815°C .

Fig. 8. Welded region of vintage vessel with curved bottom showed very little evidence of sensitization and was crack-free.
